Mobile Intel[®] Pentium[®] II Processor Specification Update

Release Date: March 2006

Order Number: 243887-051

The Mobile Pentium[®] II processor may contain design defects or errors known as errata which may cause the product to deviate from published specifications. Current characterized errata are documented in this Specification Update.

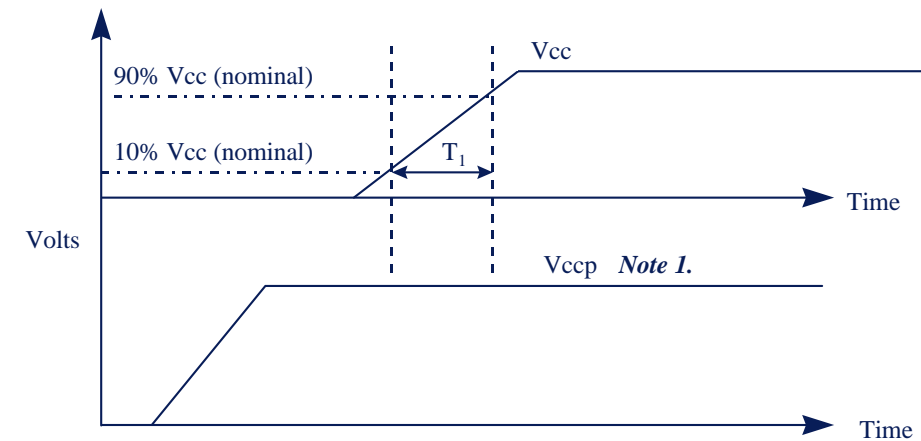
Figure 1. V_{CC}/V_{CCP} Timing Requirements (Mobile)

Problem: The processor uses the PWRGOOD signal to ensure that no voltage sequencing issues arise; no pin assertions should cause the processor to change its behavior until this signal is asserted, when all power supplies and clocks to the processor are valid and stable. However, if V_{CC} ramps up before V_{CCP} , it will cause the processor to enter an invalid state.

Implication: If this erratum occurs, the system may boot normally however, the L2 cache may not be initialized.

Workaround: For Mobile Pentium II processors, ensure that V_{CC} ramps after or with the L2 cache IO voltage (V_{CCP}). If V_{CCP} ramps after the V_{CC} , a delay circuit can be placed on the core V_{CC} to ensure that V_{CC} ramps at the same time or after V_{CCP} as shown below in Figure 1.

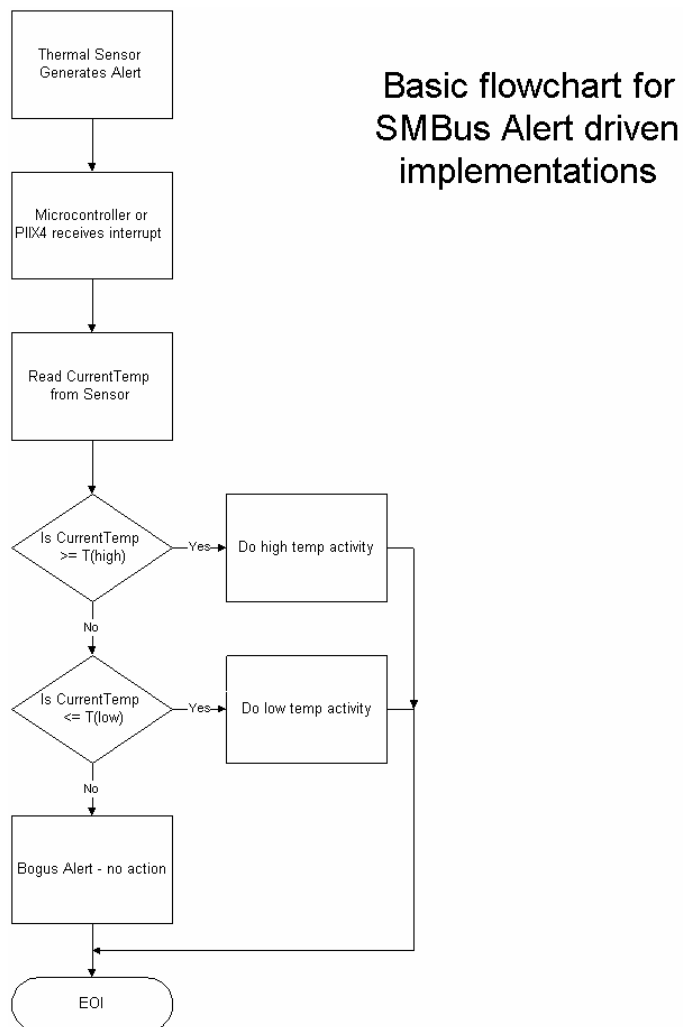
Figure 2. Workaround Flowchart: SMBALERT#-Driven System

Under the conditions described below, the thermal sensor incorrectly generates the SMBALERT# interrupt. All of the following conditions must be met to trigger a false interrupt:

1. Before servicing an interrupt from the thermal sensor, read and compare the processor thermal reading with the threshold limits (T_{HIGH} or T_{LOW}). Figures 2 and 3 provide basic flowcharts for the implementation of this workaround in an interrupt driven system.
2. If the firmware implemented polls the Status Register only, then before taking any action, re-read the temperature register and do a comparison with the alarm threshold limits (T_{HIGH} or T_{LOW}) to determine if the value is actually still within the temperature window.
